**NASA CR-72850**

# **EVALUATION OF HIGH TEMPERATURE ELECTRICAL MATERIALS AND COMPONENTS**

**A. J. Krause, W. S. Neff and J. W. Toth**

**Westinghouse Electric Corporation  
Aerospace Electrical Division  
Lima, Ohio**

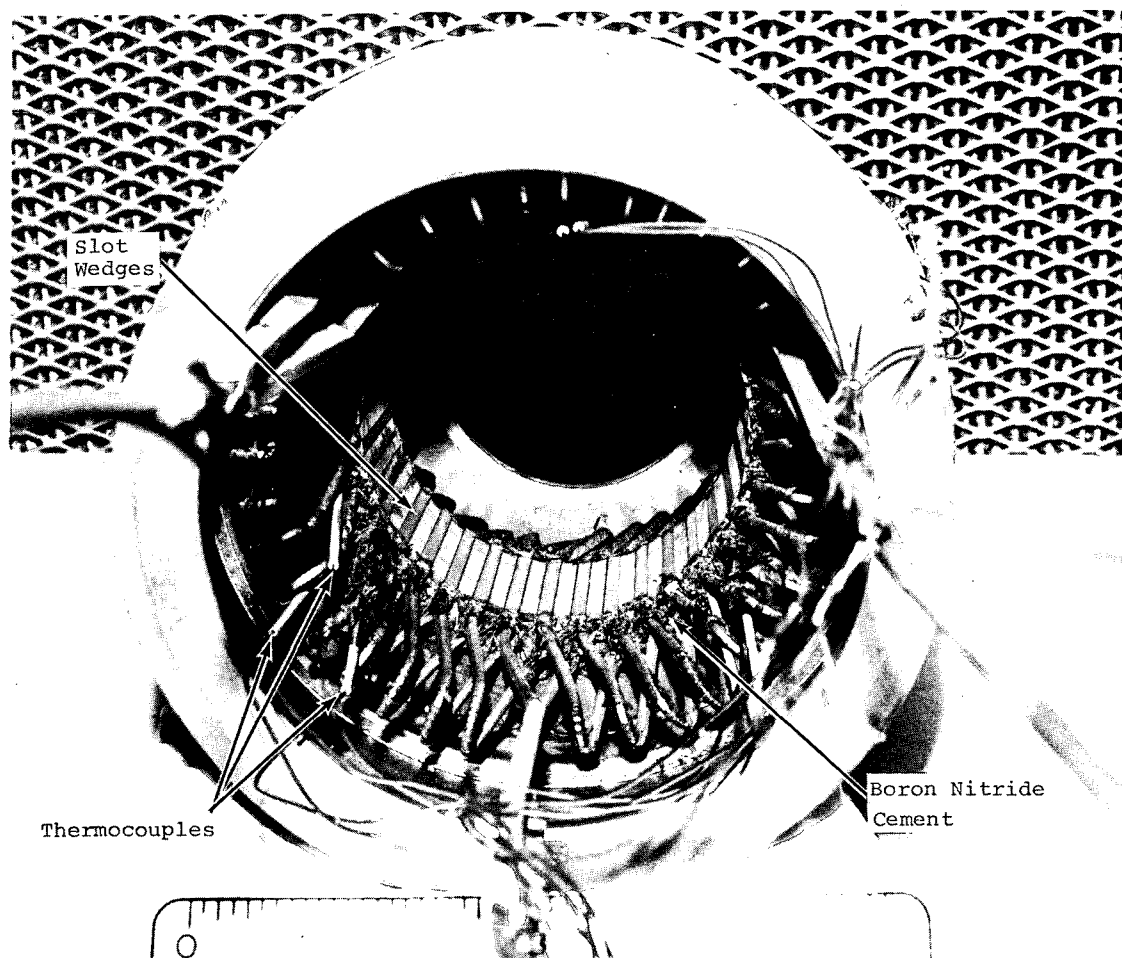
Figure 17. - Photograph of the Stator Interior After Completion of a 10,000-Hour Test at 1300° F in Vacuum.

Visual Examination of the Stator After Removal from the Test Chamber - A visual examination of the stator, performed immediately after removal from the test chamber, revealed some gray discoloration of the insulation materials and a general dulling of the exposed metallic surfaces attributed to deposition of evaporated materials during thermal-vacuum aging. The exposed surfaces of the conductor insulation were gray. Many of the conductor insulation "S" glass fibers on the conductor end turns had been fractured during winding, thereby causing some fraying; but this condition had not progressed further during the aging (see figure 17). The glass fibers were mechanically weak with low interfiber bonding. The adhesion of the wire insulation to the Inconel cladding was also weaker than after firing. The Inconel surface under the insulation was bright and not discolored.

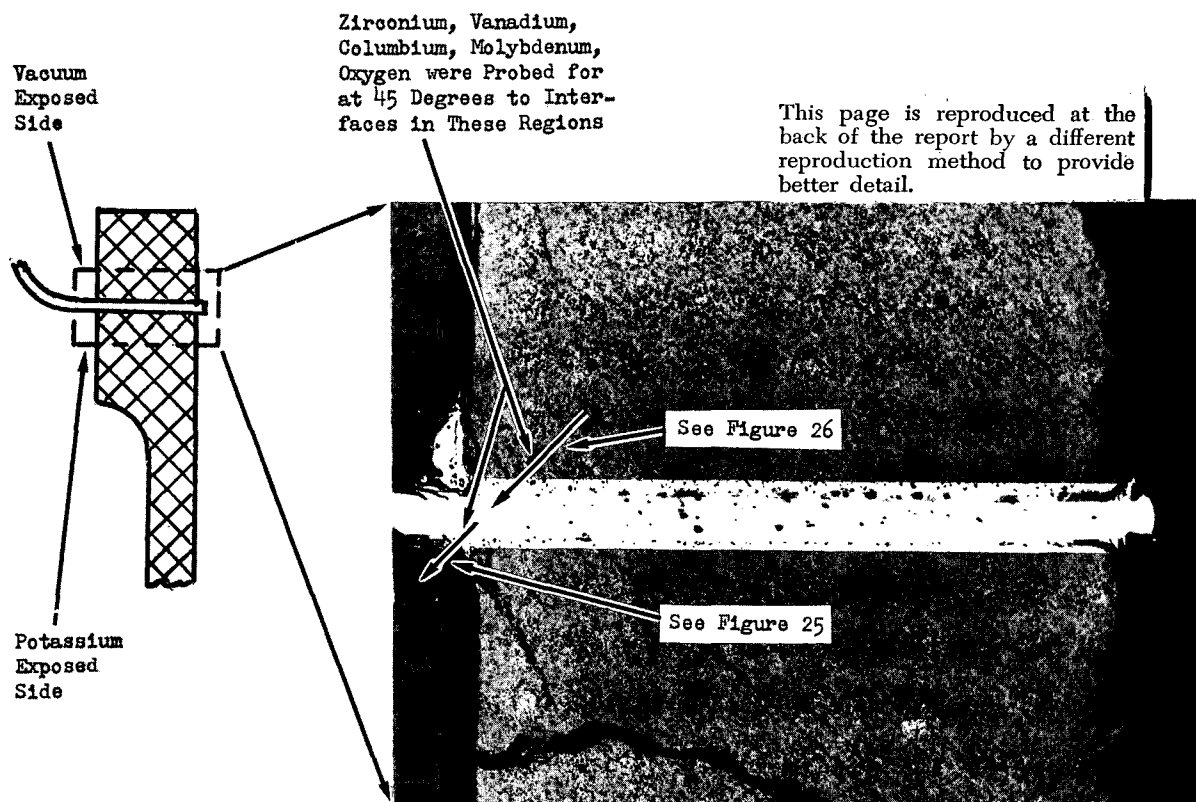
Figure 21. - Photograph Showing Cross Sections of Brazed Joints, From Top of 4-Inch Diameter by 4-Inch High Bore Seal Capsule After Exposure to Potassium at 1300° F For 10,000 Hours. (16X)

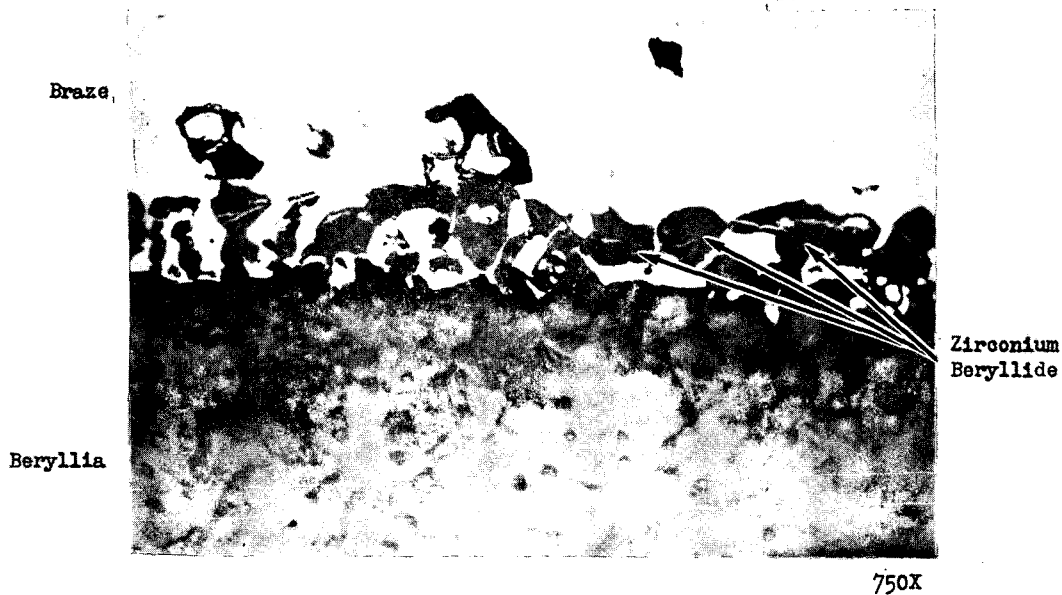
with 83 weight percent zirconium. The probable composition of the areas referenced in figures 27 and 28 is  $\text{ZrBe}_2$ . Another structure identified from microprobe analyses is the zirconium peak shown in both figures 24 and 25 at 55 microns into the braze from the edge of the columbium-1% zirconium. These peaks correspond to the 80Zr-20Cb eutectoid.

Good wetting characteristics of the braze alloy with respect to both columbium-1% zirconium and beryllia are evident in figures 27 and 29. Joint integrity was retained.

Figure 27. - Photomicrograph of Beryllia/Braze Interface of Bottom Brazed Joint of Bore Seal Capsule After 10,000 Hours at 1300° F Exposure. (750X, Bright Field)

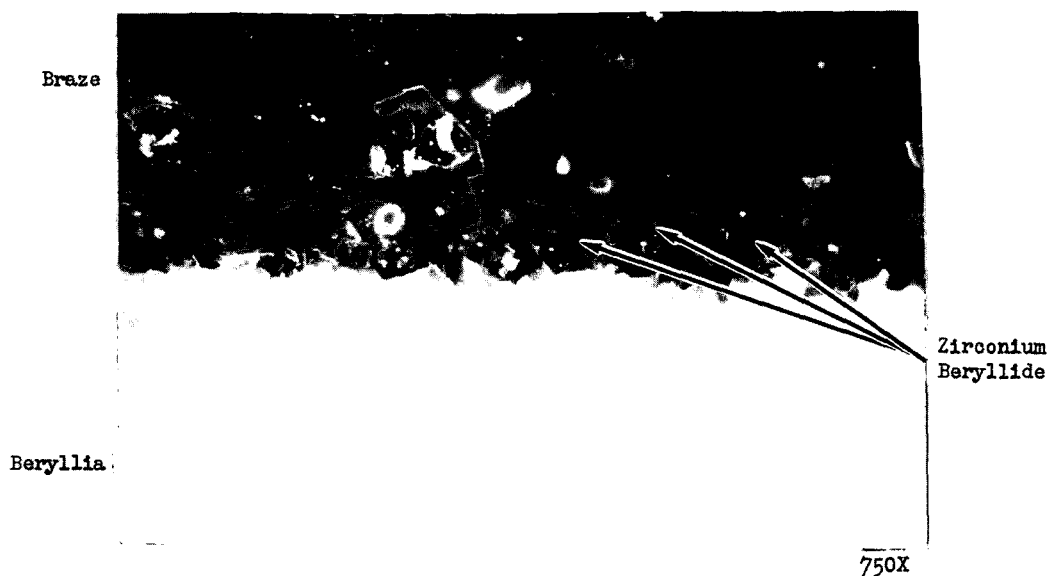
Figure 28. - Photomicrograph of Beryllia/Braze Interface of Bottom Brazed Joint of Bore Seal Capsule After 10,000 Hours at 1300° F Exposure. (750X, Dark Field)

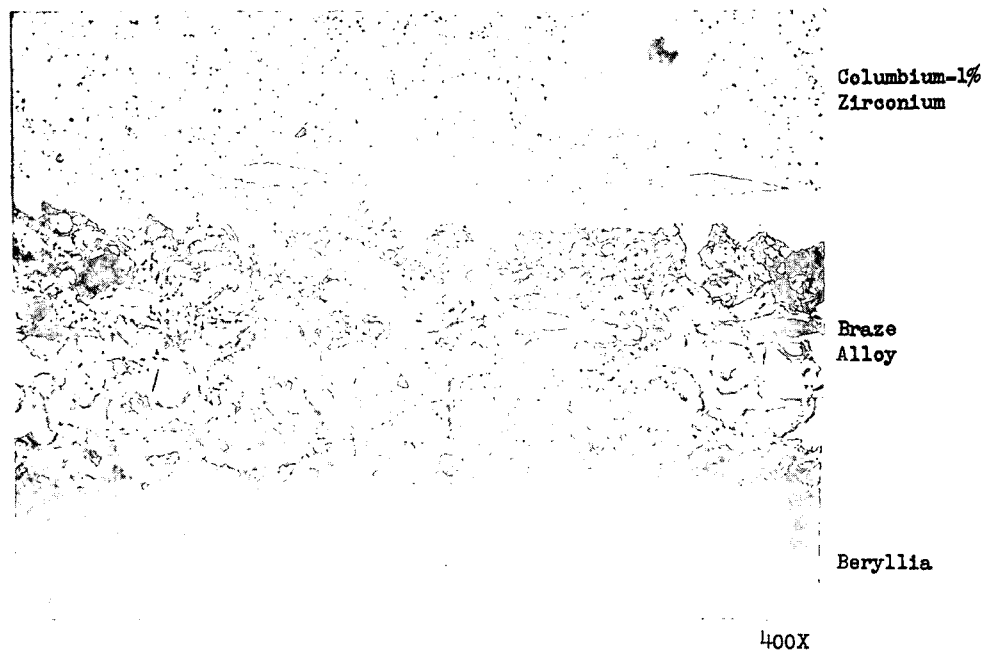
Figure 29. - Photomicrograph of Bottom Bore Seal Capsule Brazed Joint After 10,000 Hours 1300° F Exposure. Joint is Between Columbium-1% Zirconium and Beryllia Using 60Zr-25V-15Cb Braze Alloy. (400X)

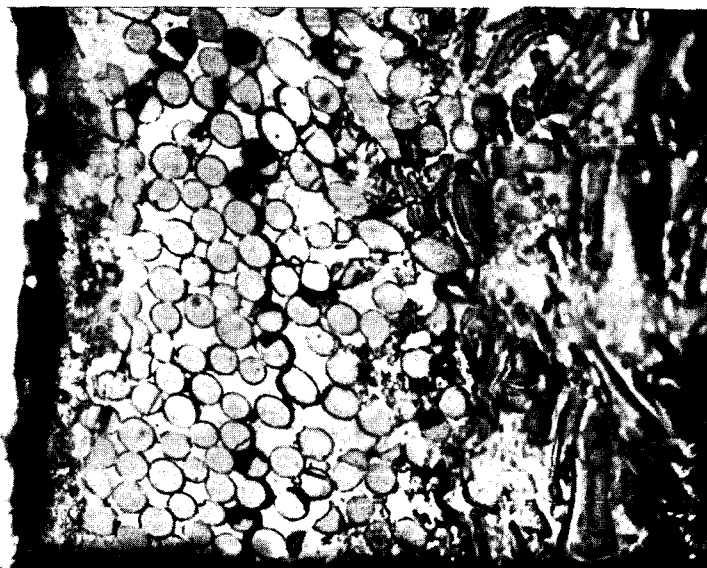
Microscopic Examination of Conductor Insulation. - A transverse section of aged stator Inconel-clad silver conductor with Anadur "S" insulation was prepared for microscopic examination. A photomicrograph of this section is presented in figure 30 accompanied by that of an unaged specimen, figure 31. Examination of the aged specimen showed that the "S" glass fibers remained discrete and were not dissolved to a significant degree by the glass/refractory oxide matrix of the Anadur "S" insulation. The non-uniform appearance of the insulation coating in figure 30 was caused by the mechanical disturbances of sectioning,

Figure 30. - Photomicrograph of Stator Conductor Electrical Insulation After Aging (10,000 Hours at 1300° F Ultrahigh Vacuum). (400X)

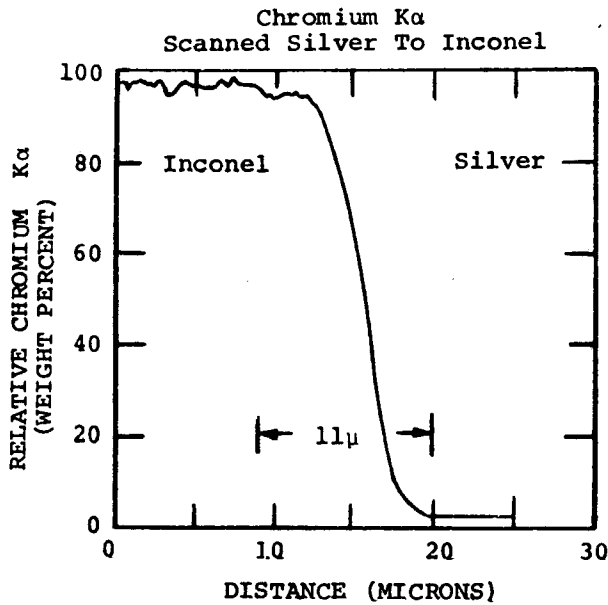
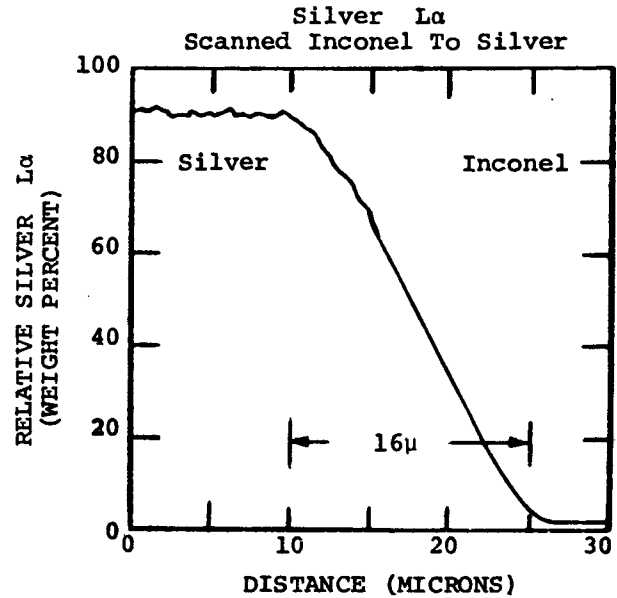
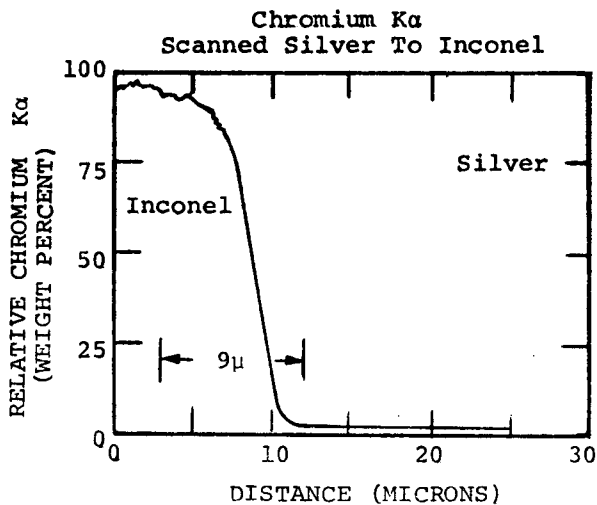
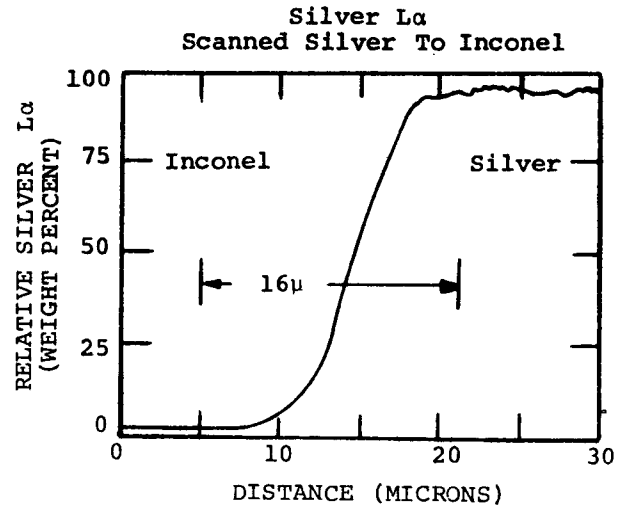
Figure 32. - Electron Microprobe Scans For Silver and Chromium in Aged (10,000 Hours at 1300° F Ultrahigh Vacuum) and Unaged Stator Inconel-Clad Silver Conductors.

indicated as being the interface. Silver could not be detected anywhere in the Inconel cladding nor could chromium be detected in the silver.

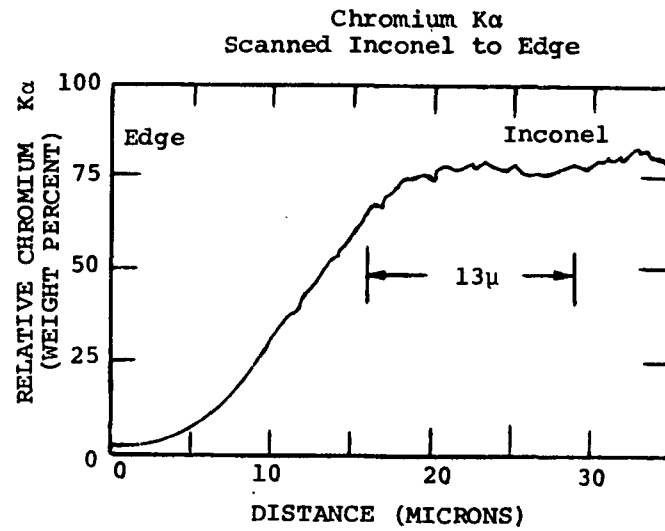
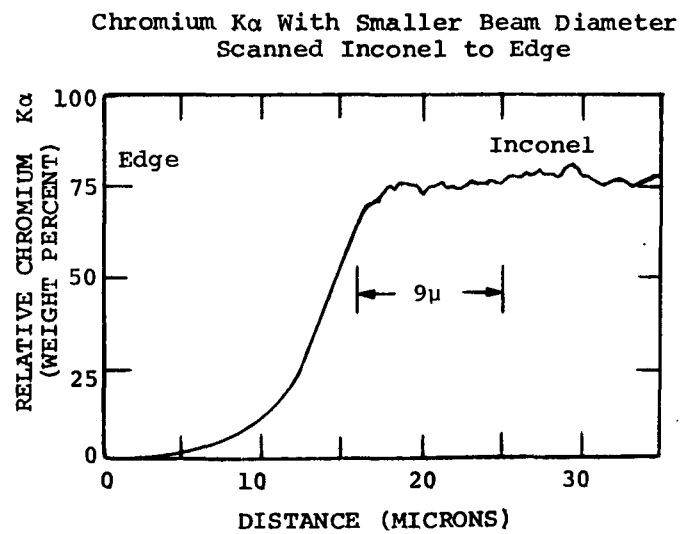
A check was made for possible chromium depletion from the outside of the aged Inconel specimen. A chromium scan was made from the silver interface across the width of the cladding. There was some indication that the chromium content might have decreased from 14 percent to 13 percent in the last 10 microns, but due to edge effects (rounding the specimen in polishing), this is very difficult to confirm. The beam size was reset to a smaller (nearer one micron) diameter and the edge area was rerun. There was even less evidence of any chromium depletion at the vacuum-exposed edge when the smaller beam was used. Figure 33 gives two charts showing these two scans.

Figure 33. - Electron Microprobe Scans For Chromium in Inconel  
From Aged (10,000 Hours at 1300° F Ultrahigh  
Vacuum) Stator Conductor Specimen.

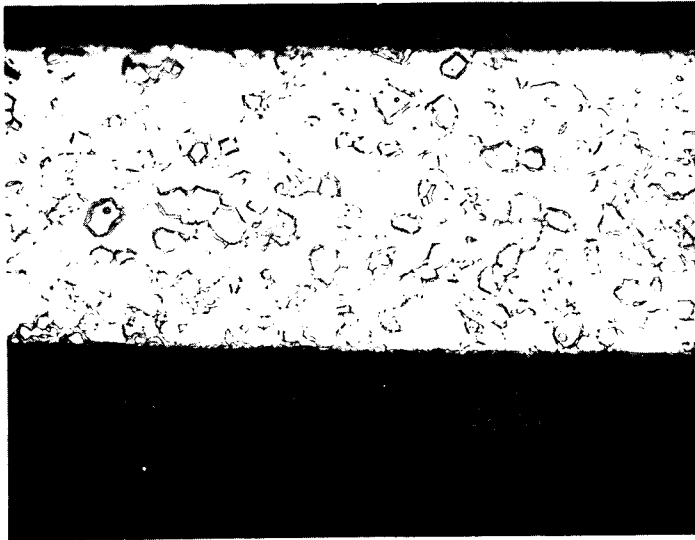
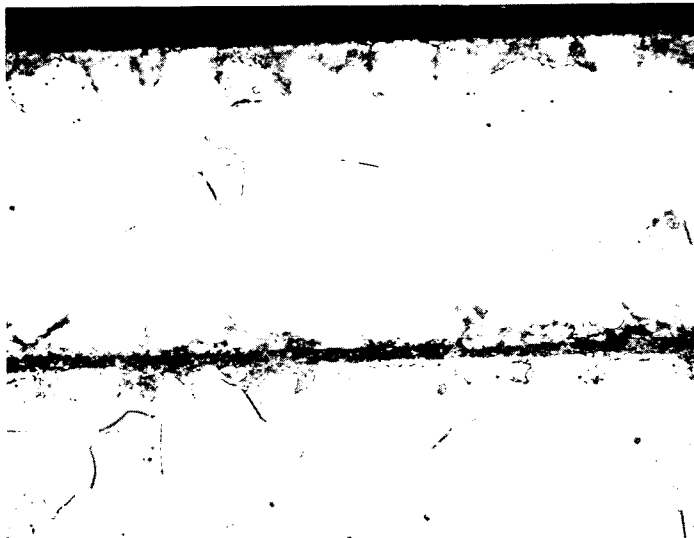
Metallographic Examinations and Microhardness Surveys of Magnetic Materials. - An investigation of the microstructure was carried out and the results were correlated with microhardness tests and bend ductility observations. These data show that high temperature vacuum exposure brought about internal oxidation of the outer layers of laminations as well as intergranular brittleness. The samples tested here were as brittle as the phosphate-coated laminated core which had successfully passed a vibration test (ref. 5, p. 167).

Internal oxidation occurred by oxygen diffusion from the laminations surface through grain boundaries and into the grains; this produced a network of oxide inclusions. Figure 36 shows this structure. The inclusion network increased the hardness (table 13) in the material layers close to the surface and prevented further grain growth. The grains in the center layers of the aged samples grew to three to five times their original size. This grain growth, however, was conducive to interlaminar brittleness because grain boundaries contain oxygen, the relative concentration of which increases with the reduction in the length of grain boundary network (grain growth). This mechanism applies to both thin laminations and thick sections except that grain growth was more pronounced in laminations because the surface area to volume ratio was larger in the case of laminations.

Second Phase Penetration  
into Lamination Surface

Figure 36. - Photomicrographs of Iron-27% Cobalt Magnetic Laminations Used in the High Temperature Stator Before and After Thermal Aging for 10,000 Hours at 1300° F and a Pressure in the  $10^{-9}$  Torr Range.

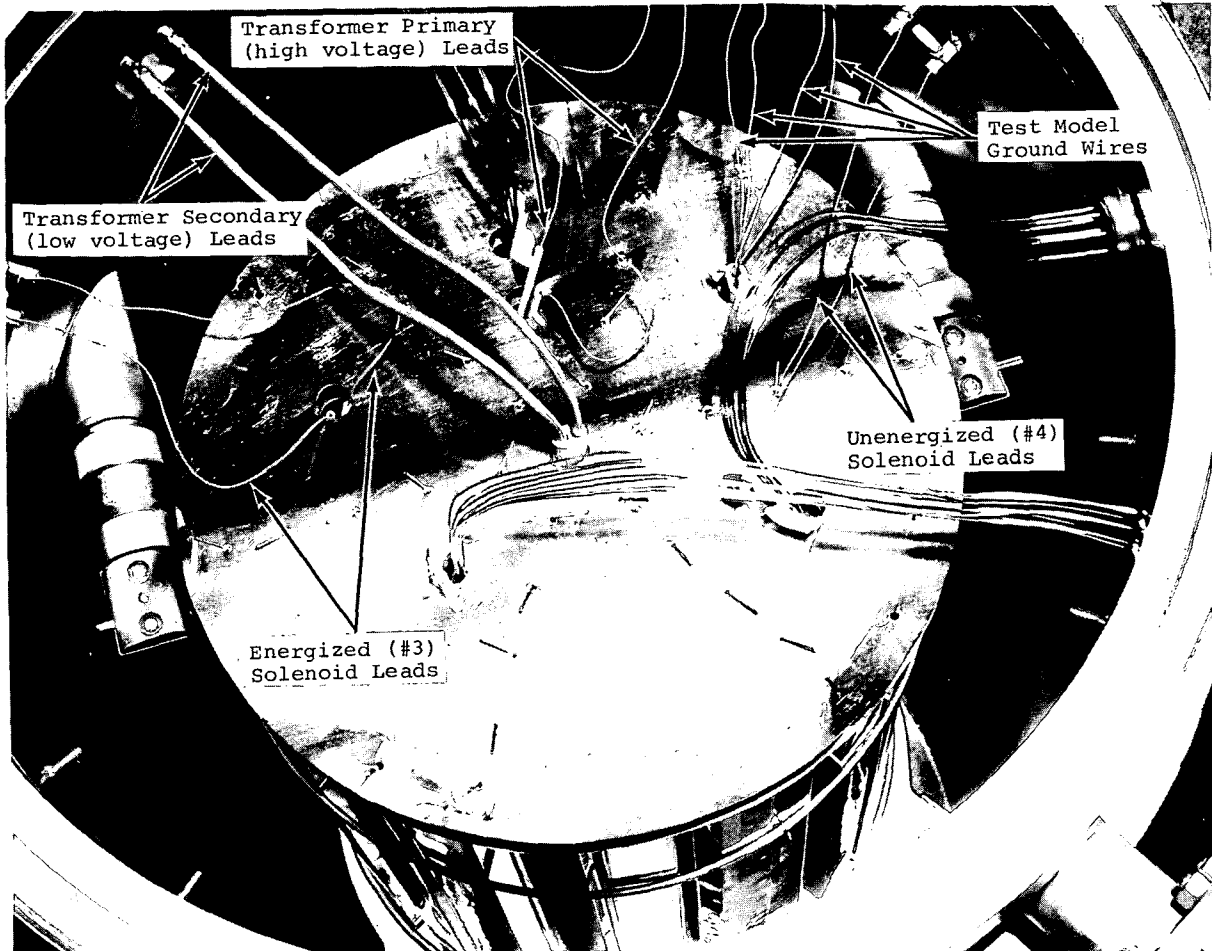
After measurements were completed, the test chamber was raised to ambient pressure using dry nitrogen as the cover gas, and the top cover was removed. Figure 39 is a photograph of the top of the test chamber after cover removal. Thermocouples were brought through the top heat shields in groups of eight. Transformer and solenoid leads are as noted on the photograph. Inspection showed that both lead wires to the energized solenoid were grounded to the top chamber heat shield. The hollow aluminum tubes which were used to insulate the leads as they passed through the heat shields had slipped down, one at a time, until each lead became grounded to the chamber. After the insulators were pulled back into position, the solenoid functioned normally, repeating pre-test bench test values for conductor resistance and insulation performance. Voltage and current values required to pick up and hold the plunger and weight also repeated pre-test bench test values. Thus, the energized solenoid did not suffer an internal failure. The problem was caused by chamber installation procedure and the vibrations that occurred in the test area.

Figure 39. - Transformer and Solenoid Test Chamber with Top Removed After Thermal Vacuum Testing.

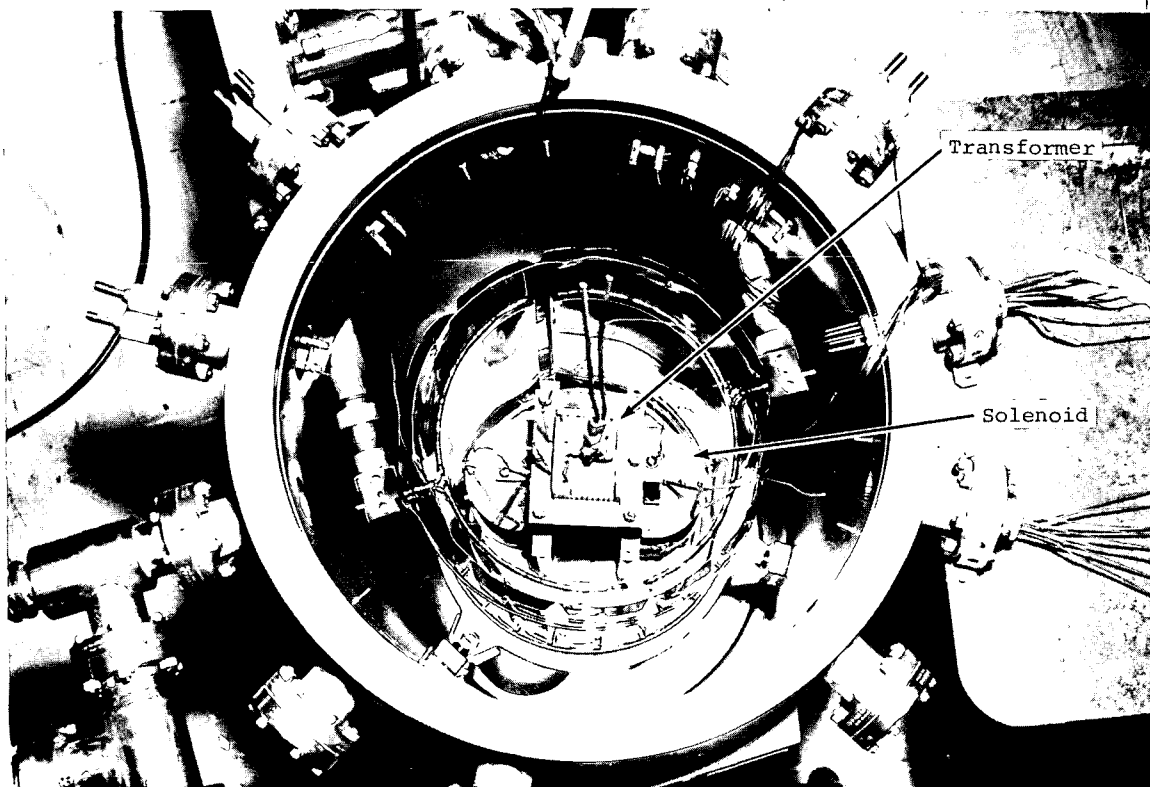
Figure 40 is a view of the chamber with the top heat shields removed. The transformer and two solenoids are shown in position on the model support fixture. Figure 41 is another view of the solenoids with the transformer removed from the chamber. The generally clean condition of the test chamber can be noted by the reflections inside the heating element and on the outside of the outer heat shield. Figure 42 shows the test chamber with the solenoids and support fixture removed.

Figure 40. - Photograph of the Transformer and Two Solenoids in the Test Chamber With Top Heat Shields Removed After Thermal Vacuum Testing.

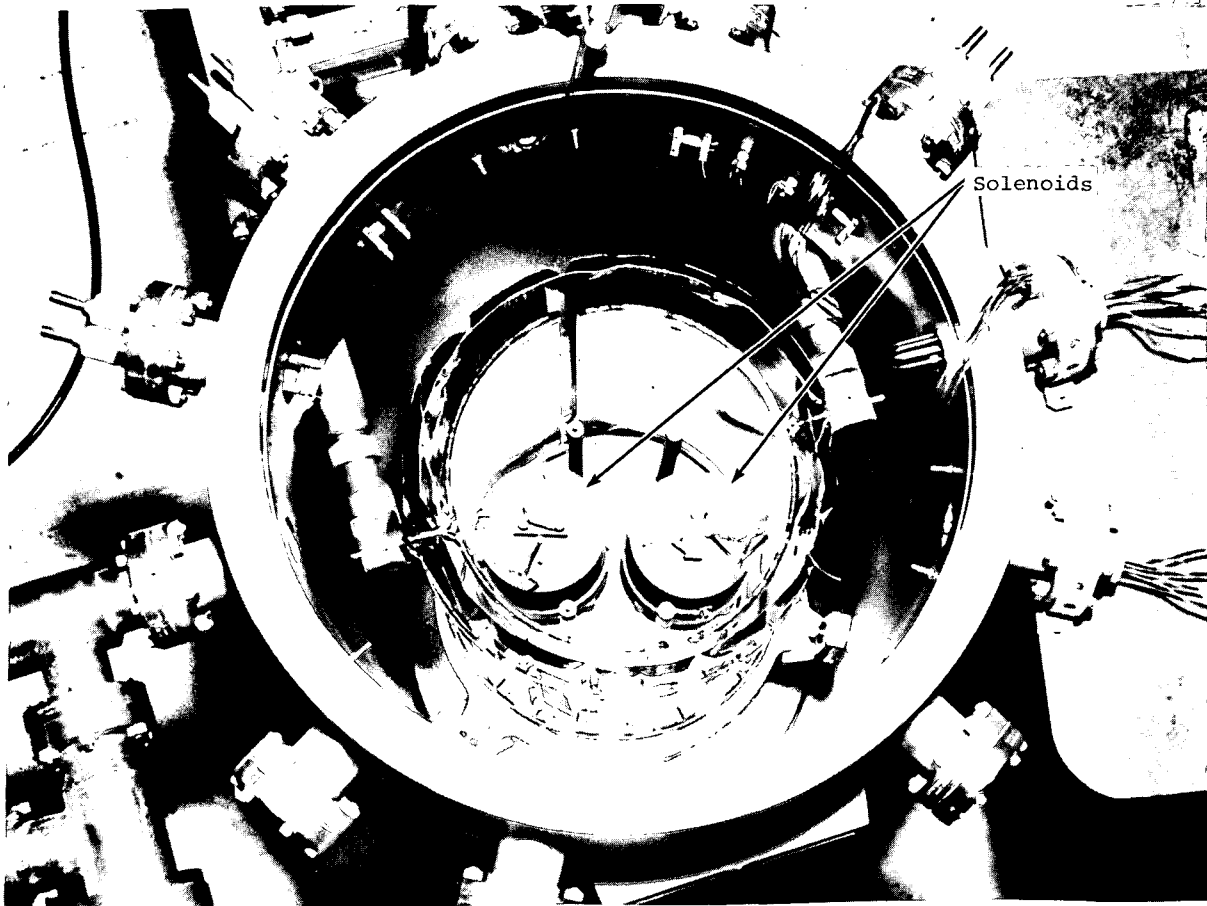
Figure 41. - Photograph Showing the Two Solenoids in the Test Chamber After Thermal Vacuum Testing. Transformer Has Been Removed.

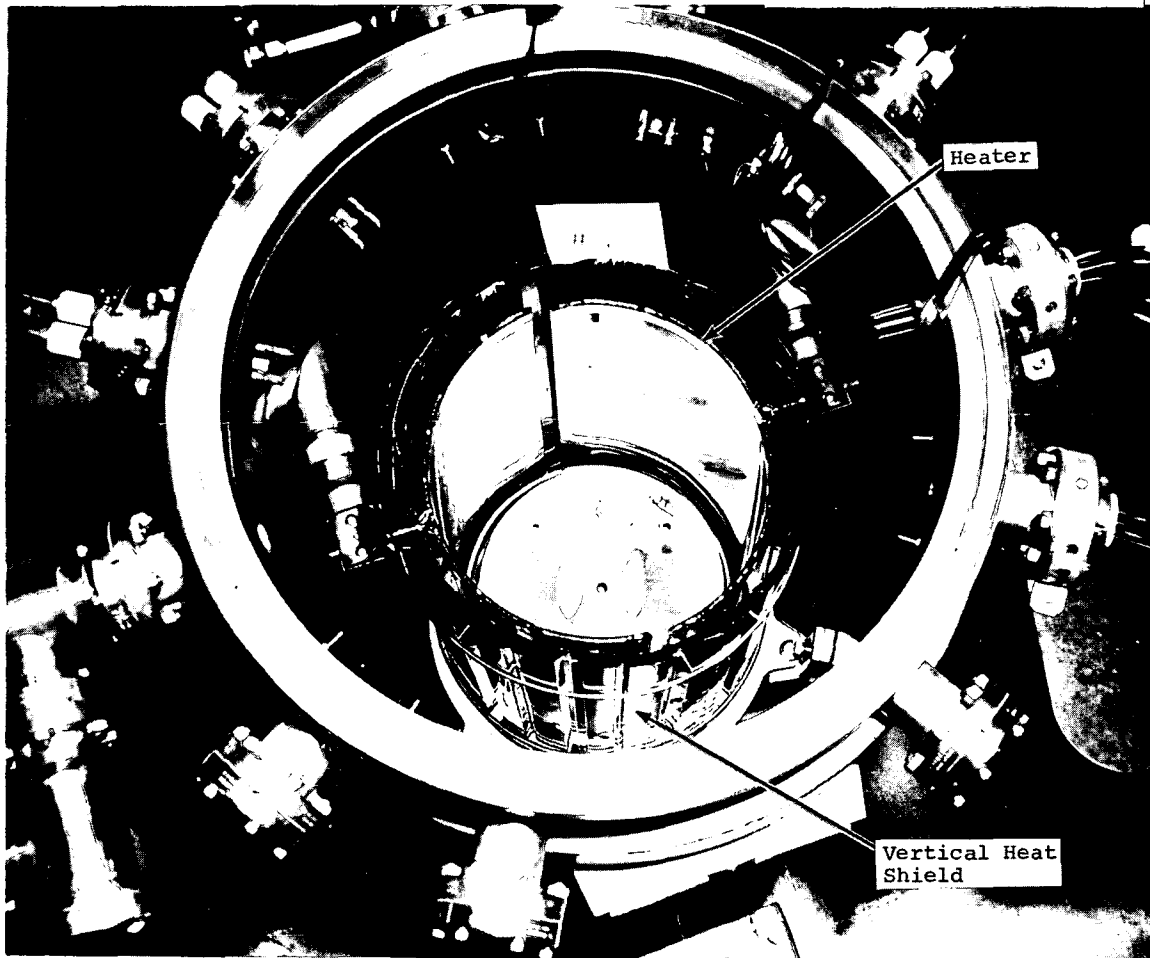
Figure 42. - Photograph of the Interior of the Test Chamber After Thermal Vacuum Testing. Transformer and Two Solenoids Have Been Removed.

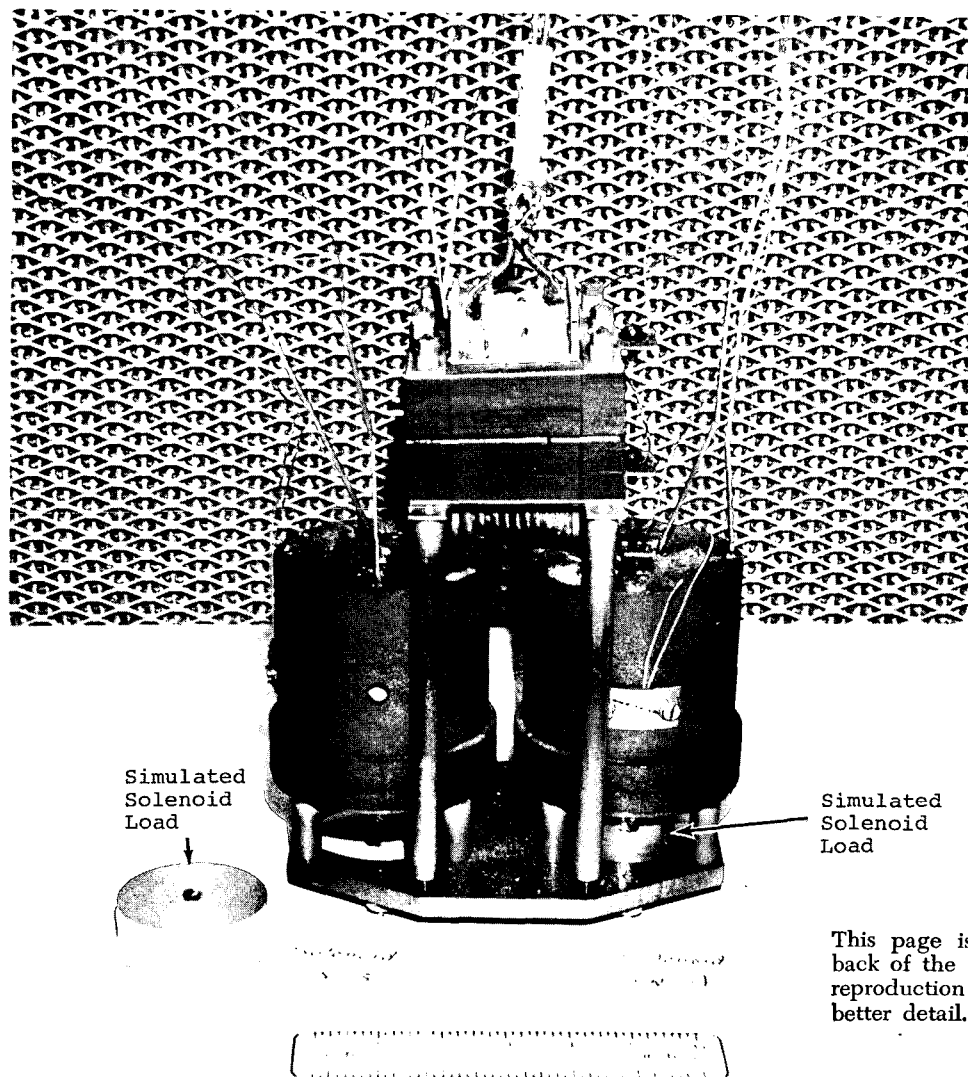
Figure 43 is a photograph of the transformer, solenoids and support fixture. The powdery material seen on the flat surfaces is loose conductor insulation which was disturbed when dry nitrogen was admitted to bring chamber pressure up to ambient pressure. The weight from the continuously energized solenoid is also displayed in the photograph.

Visual Examination. - Visual examination showed all exterior surfaces to be discolored. The normally white insulation and bright metal surfaces had a dull gray appearance, due to the deposition of evaporated materials. The ceramic spool end plates had a pattern of deposits indicating line-of-sight deposition.

Figure 43. - Photograph of the Transformer and Two Solenoids  
After Thermal-Vacuum Testing.

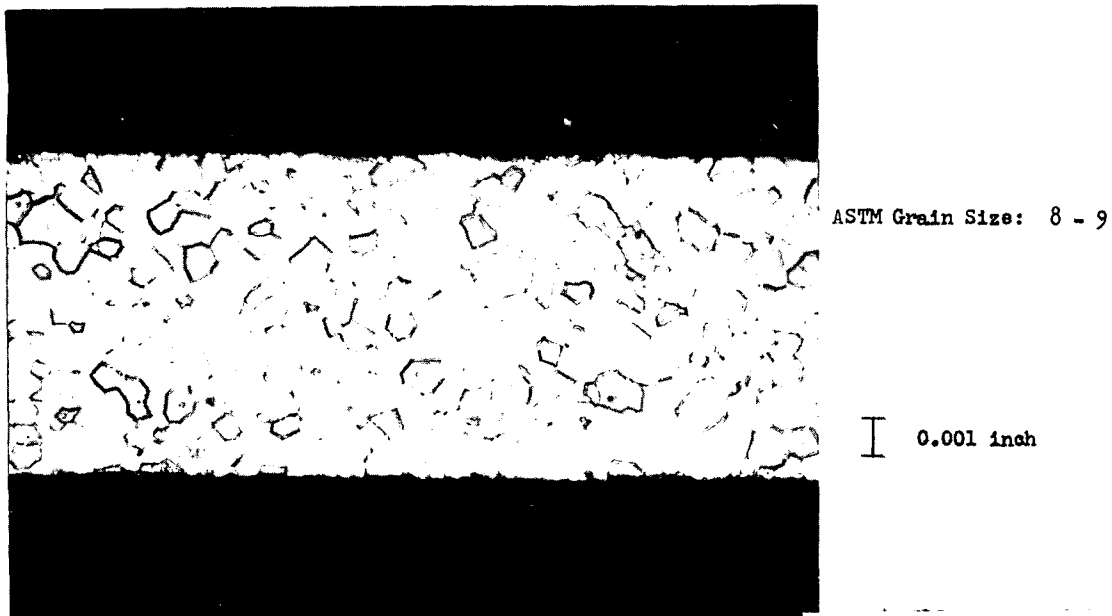
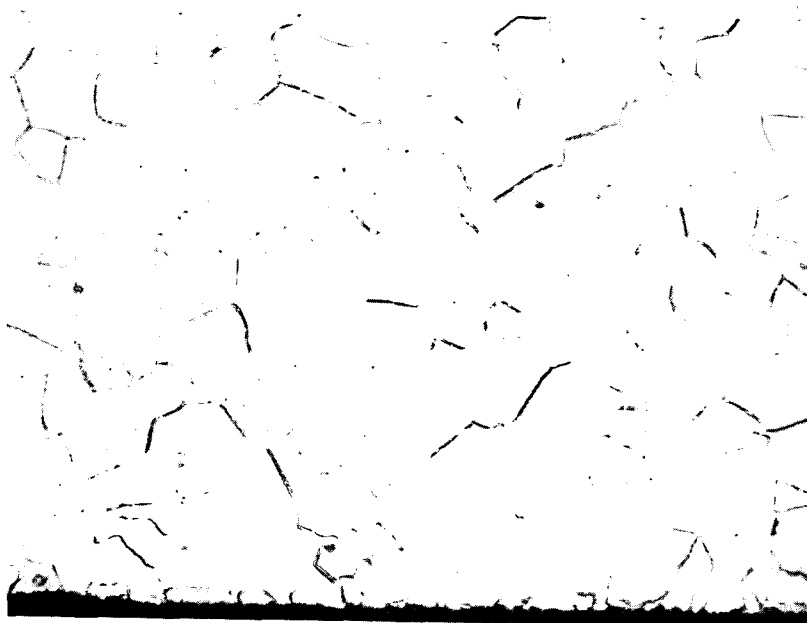
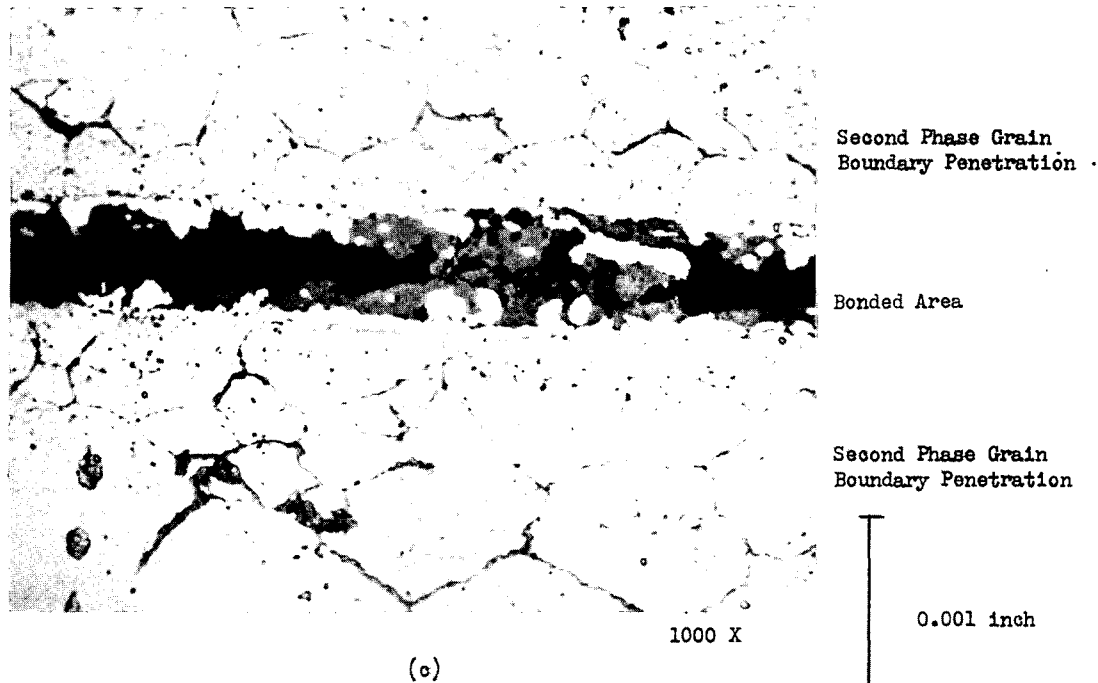
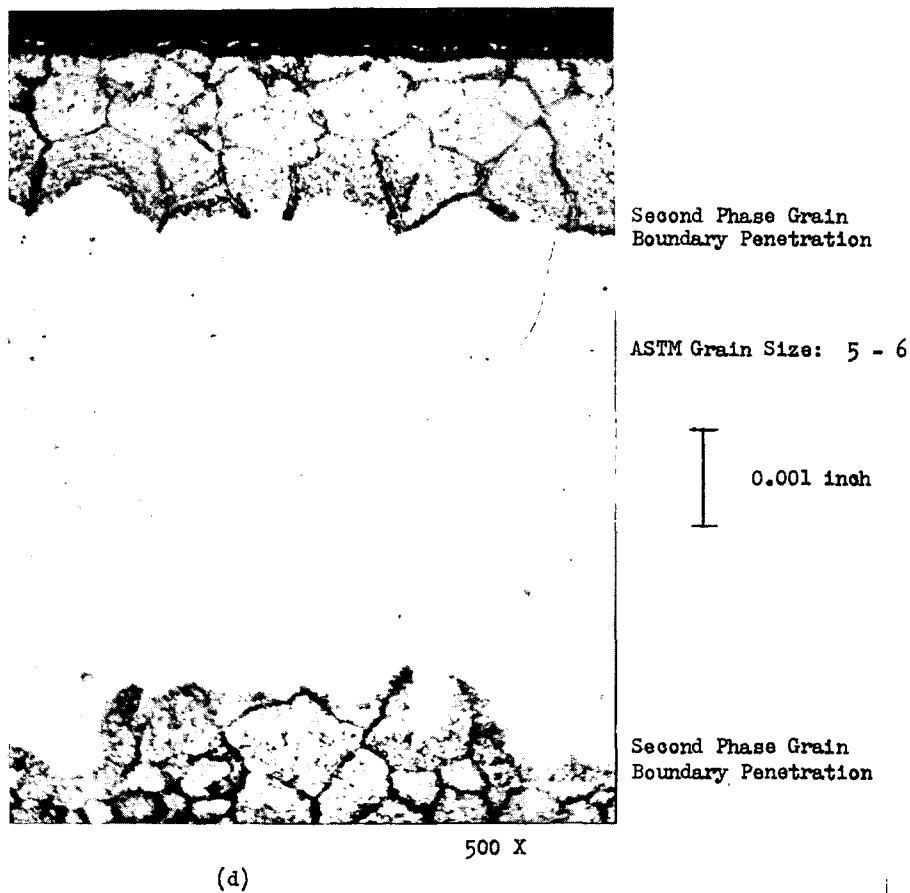
A pair of bonded laminations is shown in figure 46(c). Surface oxide had bridged the spacing between laminations resulting in laminations adhering to each other.

Figure 46. - Photomicrographs of Iron-27% Cobalt Magnetic Laminations from the Transformer Before and After Thermal Aging for 5000 Hours at a Pressure in the  $10^{-9}$  Torr Range.

- (a) Unaged iron-27% cobalt transformer lamination with plasma arc sprayed alumina interlaminar insulation (99.99+%  $Al_2O_3$ ) applied, 200X.  
Etchant: 50HNO<sub>3</sub>, 45CH<sub>3</sub>, COOH, 5H<sub>2</sub>O
- (b) Unaged iron-27% cobalt transformer lamination with plasma arc sprayed alumina interlaminar insulation applied, 500 X.
- (c) Iron-27% cobalt laminations with plasma arc sprayed interlaminar insulation applied, after 5000 hours aging at 1300° F, unetched, 1000X. Note area of "cold-weld" - area between laminations bridged by oxide caused adherence of adjacent laminations.
- (d) See next page.

- (d) Iron-27% cobalt transformer lamination with plasma arc sprayed alumina interlaminar insulation applied, after 5000-hour thermal aging, unetched, 500X.

Figure 46. - Photomicrographs of Iron-27% Cobalt Magnetic Laminations from the Transformer Before and After Thermal Aging for 5000 Hours at a Pressure in the  $10^{-9}$  Torr Range.  
(Concluded)

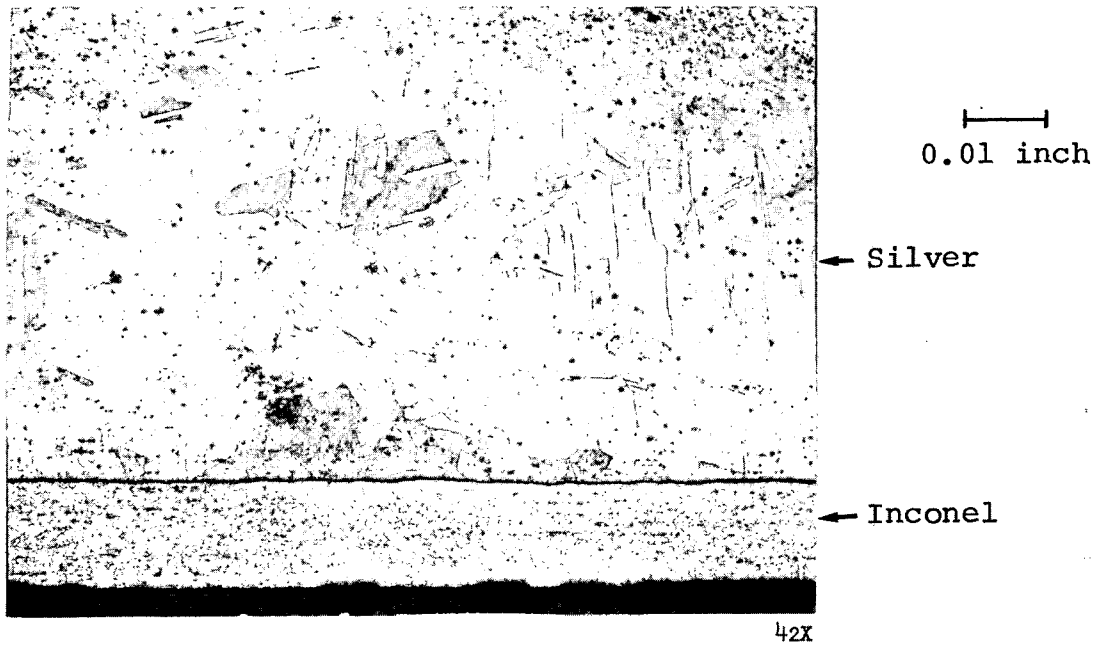
Figure 47. - Photomicrograph of Longitudinal Section of Unaged Transformer Secondary Conductor (42X)

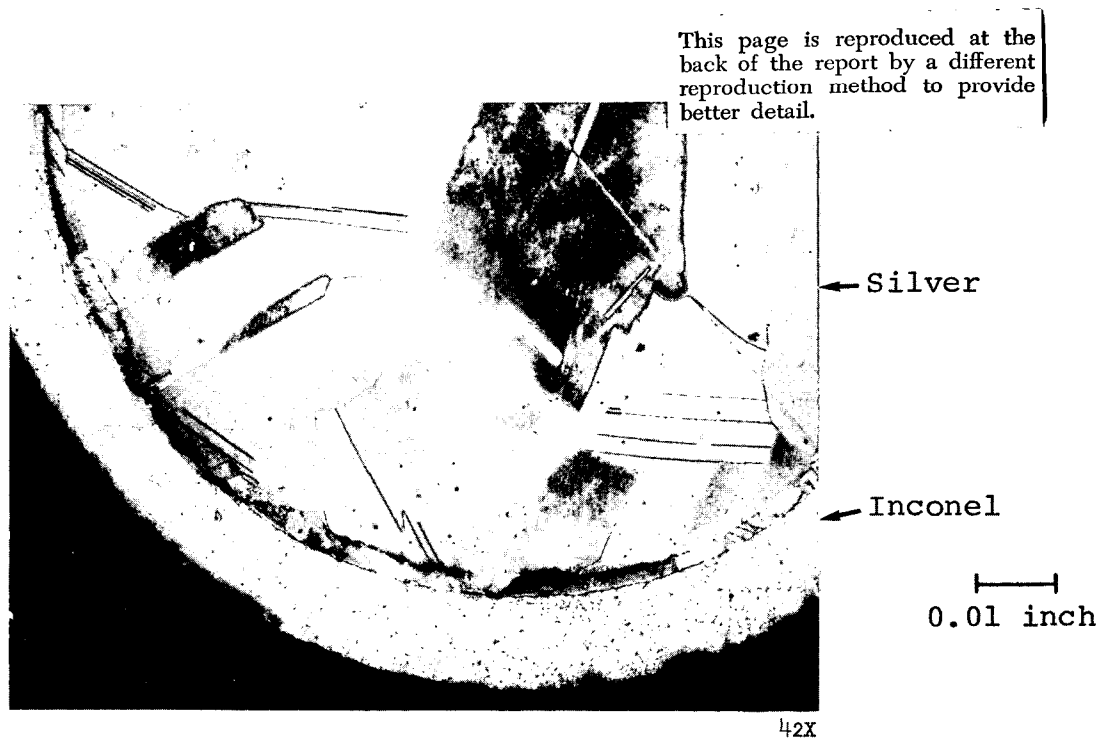
Figure 48. - Photomicrograph of Transverse Section of Transformer Secondary Conductor After 5000-Hour Thermal-Vacuum Exposure (42X)

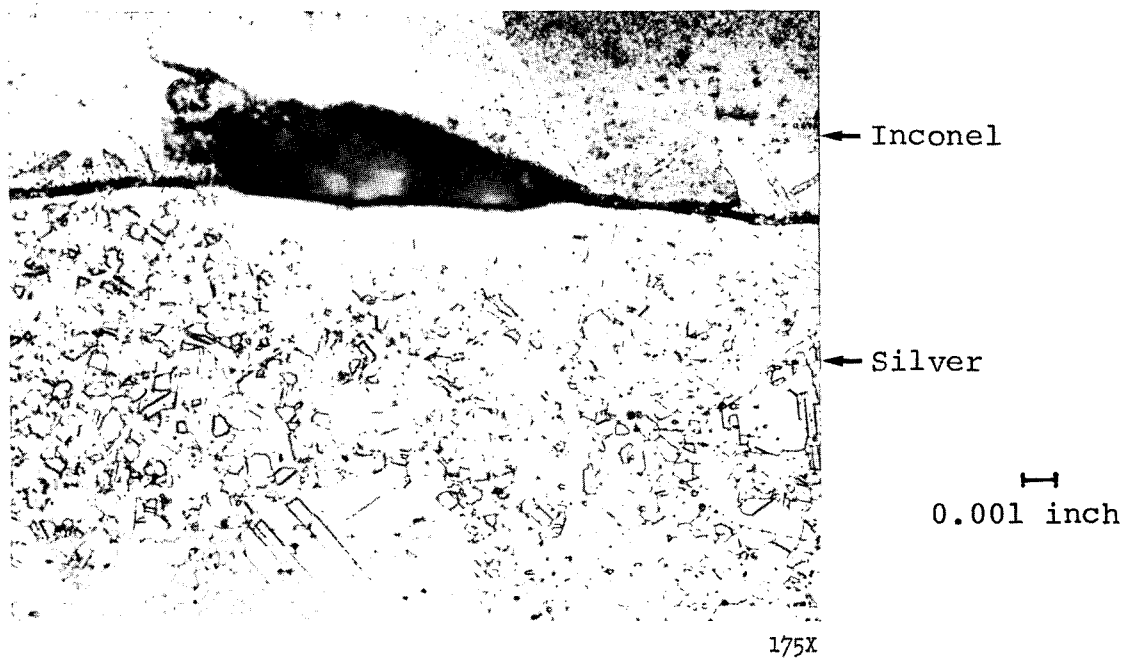
Figure 49. - Photomicrograph of Transverse Section of  
Transformer Secondary Conductor After  
5000-Hour Thermal-Vacuum Exposure  
(175X)

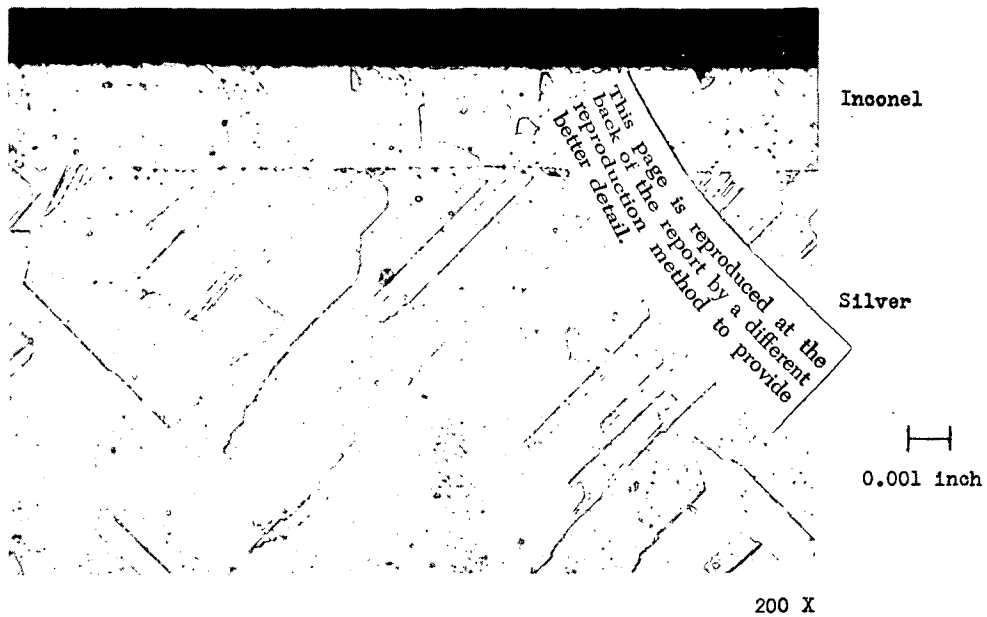
Microstructures of transformer primary conductors are shown unaged in figure 50 and as aged in figure 51. Grain growth due to thermal aging occurred in both the silver and the Inconel. Grain growth was as expected and was similar to that found in the aged secondary conductor. No evidence of voids was found in either aged or unaged primary conductor specimen.

Figure 50. - Photomicrograph of Longitudinal Section of Transformer Primary Conductor After 5000-Hour Thermal-Vacuum Exposure. (200X)

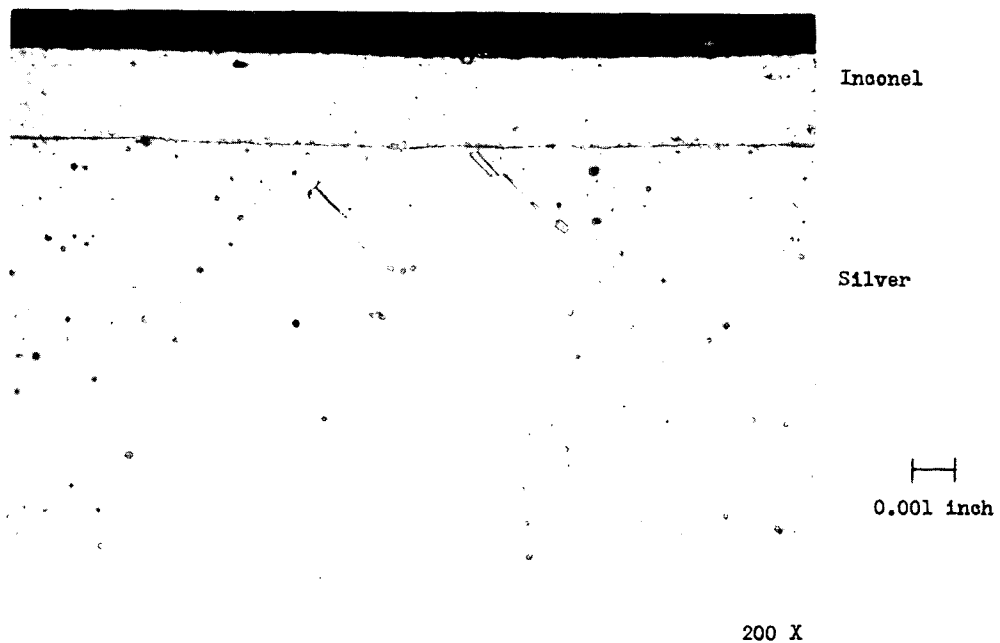
Figure 51. - Photomicrograph of Longitudinal Section of Unaged Transformer Primary and Solenoid Conductor. (200X)

Metallographic Examinations of Electrical Conductors. - Metallographic examinations were performed on Inconel-clad silver conductors, unaged and from each solenoid. The solenoid conductor is the same as that used for the transformer primary. Microstructure of the unaged material is shown in figure 51. Microstructure of the conductor from the intermittently energized solenoid is shown in figure 54. Grain growth occurred in both the Inconel and the silver during aging, as was to be expected. Large random voids in the silver are seen in figure 54. Particles of silver may be seen adhering to Inconel cladding. It is probable that the silver was molten at some time after the beginning of the cladding process (such as in strand annealing between drawing operations). The random distribution of the voids indicates a short time in the molten state (incipient melting) as there was insufficient time for the voids to coalesce. No voids were detected in the unaged conductor (figure 51).
